PHOTOGRAPHIC SURVEY OF THE LDEF MISSION

NASA Special Publication 531

Robert L. O'Neal

Langley Research Center
Hampton, Virginia 23681-0001

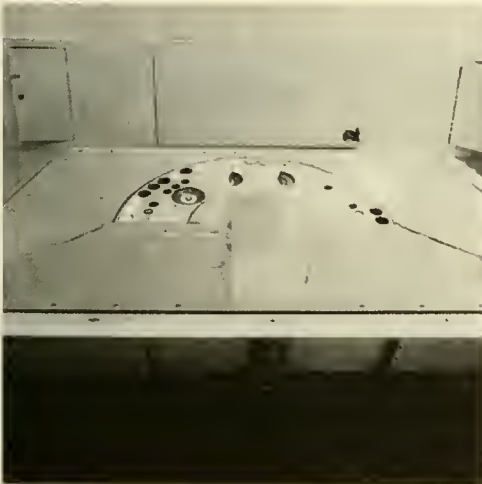
Figure 119 (Preflight). Experiment S0069 was self-contained: it included power, a data system, a reflectometer, and a preprogrammed controller for automatically exposing, monitoring, and measuring the sample materials. Experiment S0069 had 25 active and 24 passive samples mounted in a semicircular pattern (active samples on the outer radius and passive samples on the inner radius) on a circular carousel. This arrangement maximized the exposure of the samples to the combined space environment. Three radiometers were located on the innermost radius. The photograph shows the carousel rotated to the open position. The thermal shroud has an outside exposed surface covered with 2-mil silvered Teflon film bonded with an adhesive.

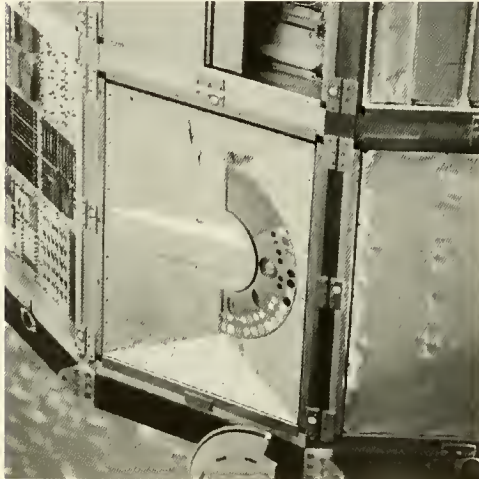
Figure 120
Photo No.: S32-76-005
Dup. Neg. No.: L90-10375
LISAR No.: EL-1994-00660
Photo Credit: JSC
Photo Date: 1/12/90
Location: In Flight
Subject: In-Flight Survey of Tray A9

Figure 120 (In Flight). Here, the original silver mirrorlike shroud surface appears white with copious amounts of a brown discoloration in a distinct pattern. The upper and lower triangular sections of the shroud have many irregular black discolorations and areas where the adhesive appears to have failed. Changes in color have occurred in both the active and the passive test samples. The three radiometers appear to have no physical damage.

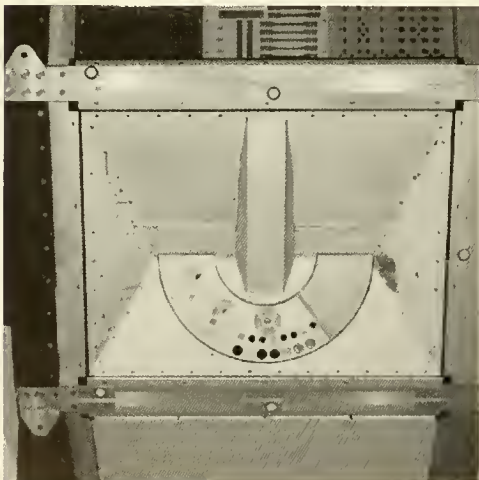
Figure 121
Photo No.: KSC-390C-1030.11
Dup. Neg. No.: L90-13409
LISAR No.: EL-1994-00144
Photo Credit: KSC
Photo Date: 2/9/90
Location: KSC SAEF 11
Subject: Postflight Survey of Tray A9

Figure 121 (Postflight). The 2-mil silvered Teflon film surface on the shroud appears to be the same as in flight. It is white with brown discolorations in a distinct pattern. The left and right triangular sections of the shroud have many irregular black discolorations and areas where the adhesive appears to have failed.

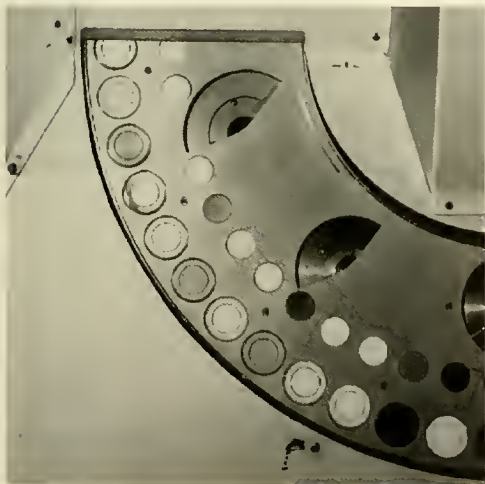
Figure 123
Photo No.: KSC-390C-1419.04
Dup. Neg. No.: L91-7716
LISAR No.: EL-1994-00376
Photo Credit: KSC
Photo Date: 2/28/90
Location: KSC SAEF II
Subject: Postflight Detail of Tray A9

Figure 123 (Postflight). This close-up photograph is of the left area of the exposed test samples. The calorimeter outer edge appears to be deformed in the fourth from top (outer) active sample location. The passive samples, located on the inner radius, seem to have no physical damage; however, some of the white paint samples now appear brown or tan. A point of space debris impact is located just off the edge of the carousel.

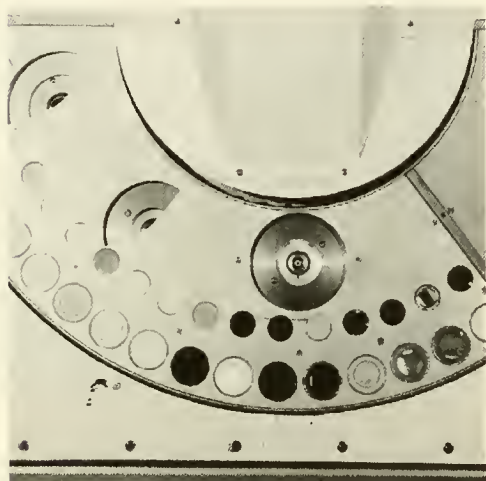
Figure 124
Photo No.: KSC-390C-1419.05
Dup. Neg. No.: L91-7717
LISAR No.: EL-1994-00377
Photo Credit: KSC
Photo Date: 2/28/90
Location: KSC SAEF II
Subject: Postflight Detail of Tray A9

Figure 124 (Postflight). This close-up is of the center area of the exposed test specimens. Some of the test specimens appear discolored and damaged. Note the first four from the right active coating samples, which are located on the outer radius. Two of the first three, which were originally white, now appear brown and have significant damage. The fourth active sample from the right, which was originally black, appears to have eroded, thus leaving only a trace of the paint or primer on the substrate. The passive samples, located on the inner radius, appear to have no physical damage; however, some of the white paint samples now appear brown or tan.

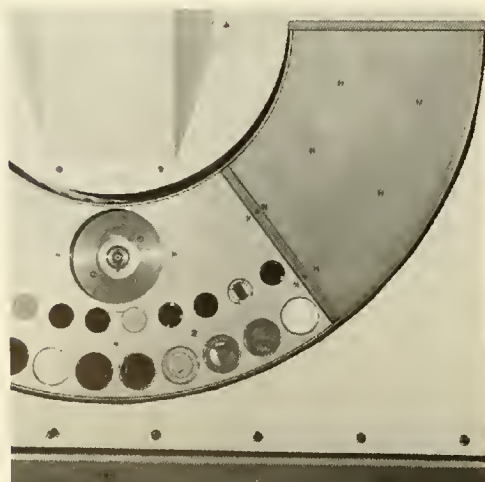
Figure 125
Photo No.: KSC-390C-1419.06
Dup. Neg. No.: L91-7718
LISAR No.: EL-1994-00378
Photo Credit: KSC
Photo Date: 2/28/90
Location: KSC SAEF II
Subject: Postflight Detail of Tray A9

Figure 125 (Postflight). This close-up photograph is of the right area of the exposed test specimens. Some of the test specimens are discolored and damaged. Note the first four from the right active coating samples located on the outer radius. Two of the first three, which were originally white, now appear brown and have significant damage. The fourth active sample from the right, which was originally black, appears to have eroded, thus leaving only a trace of the paint or primer on the substrate. The passive samples, located on the inner radius, appear to have no physical damage; however, some of the white paint samples now appear brown or tan.

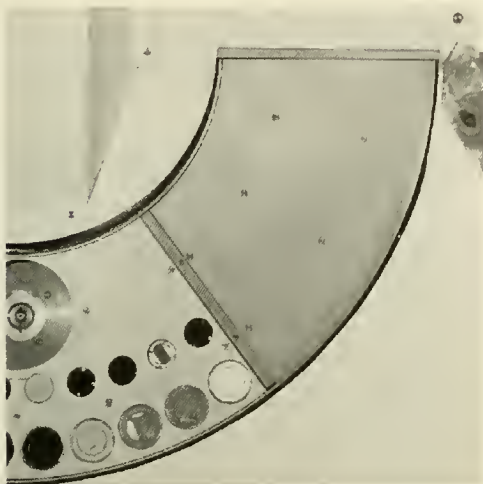
Figure 126
Photo No.: KSC-390C-1419.07
Dup. Neg. No.: L91-7719
LISAR No.: EL-1994-00379
Photo Credit: KSC
Photo Date: 2/28/90
Location: KSC SAEF II
Subject: Postflight Detail of Tray A9

Figure 126 (Postflight). This close-up of the right area of the carousel and tray bottom shows the area of damaged silvered Teflon film. Numerous discolorations from space debris impacts are also visible.

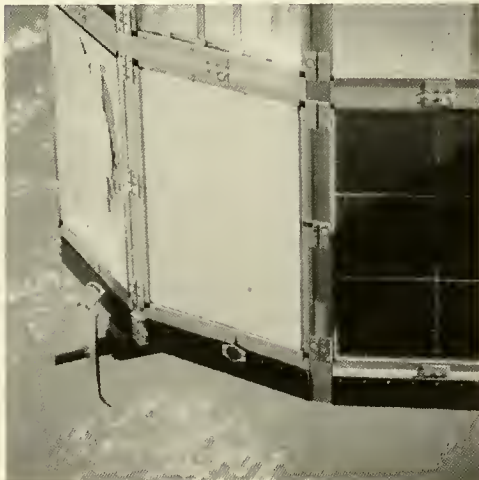
Figure 127 (In Flight). Note the dark brown stain on the LDEF structure adjacent to the edge of the black thermal panel. The thermal cover surface of experiment AO178 appears to have changed from specular to opaque with many black dots of various sizes that appear to be impact or penetration discolorations. A large discoloration is clearly visible in the lower right quadrant of the thermal cover. Many discolorations appear to be encircled by white halos. Numerous circular white discolorations that seem to be impacts are visible on the surface of the cover. The cover appears to be more taut than in the prelaunch photograph and the locations of Velcro attachment pads are apparent. The ground strap appears to be in place and to have no visible damage, but it appears to be a darker color.

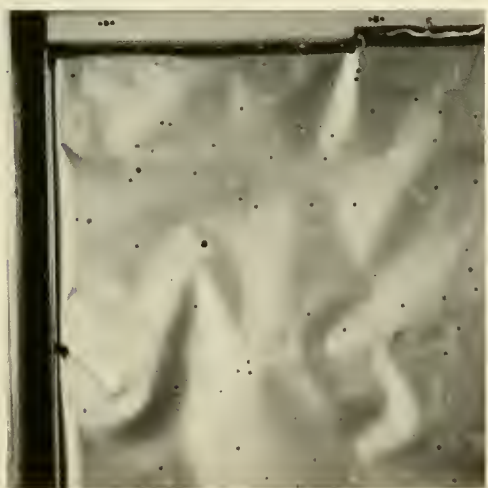
Figure 129
Photo No.: KSC-390C-2208.03
Dup Neg. No.: L91-7776
LISAR No.: EL-1994-00509
Photo Credit: KSC
Photo Date: 3/22/90
Location: KSC SAEF II
Subject: Postflight Detail of Upper Left of Tray A10

Figure 129 (Postflight). This close-up photograph of the upper left one-sixth of the tray shows numerous space debris impact or penetration discolorations. White dots of various sizes are visible on the cover and many appear to be encircling impact locations. The silvered Teflon film surface appears diffuse rather than specular as it was in preflight photographs.

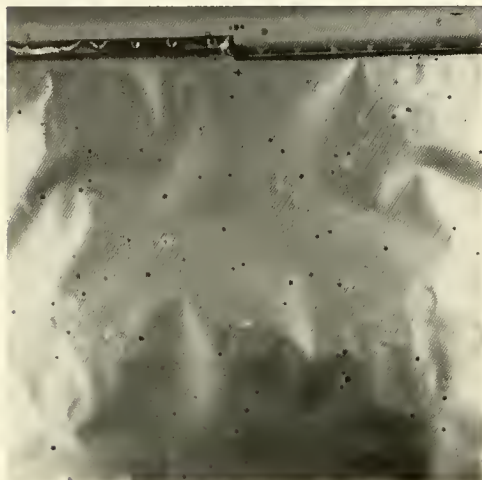
Figure 130
Photo No.: KSC-390C-2208.04
Dup. Neg.: L91-7777
LISAR No.: EL-1994-00510
Photo Credit: KSC
Photo Date: 3/22/90
Location: KSC SAEF II
Subject: Postflight Detail of Upper Center of
Tray A10

Figure 130 (Postflight). This photograph is of the upper center one-sixth of the tray. It shows numerous space debris impact or penetration discolorations. White dots of various sizes are visible on the cover and many appear to be encircling impact locations. The silvered Teflon film surface appears diffuse rather than specular as it was in preflight photographs.

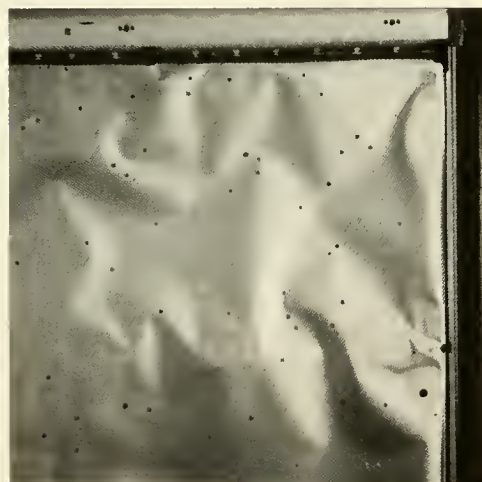
Figure 131
Photo No.: KSC-390C-2208.05
Dup. Neg. No.: L91-7778
LISAR No.: EL-1994-00530
Photo Credit: KSC
Photo Date: 3/22/90
Location: KSC SAEF II
Subject: Postflight Detail of Upper Right of
Tray A10

Figure 131 (Postflight). This photograph is of the upper right one-sixth of the tray. It shows numerous space debris impact or penetration discolorations. White dots of various sizes are visible on the cover and many seem to be encircling impact locations. The silvered Teflon film surface appears diffuse rather than specular as it was in preflight photographs.

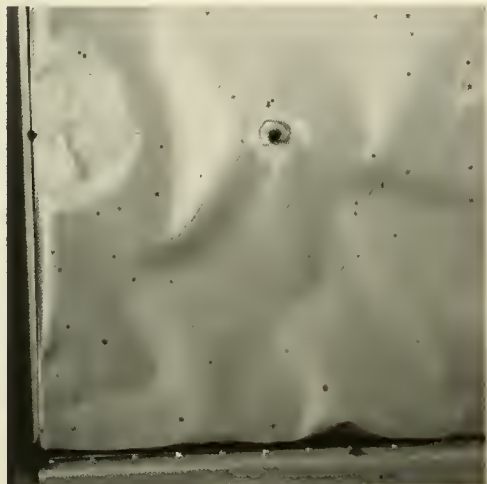
Figure 132
Photo No.: KSC-390C-2208.09
Dup. Neg. No.: L91-7782
LISAR No.: EL-1994-00531
Photo Credit: KSC
Photo Date: 3/22/90
Location: KSC SAEF II
Subject: Postflight Detail of Lower Left of Tray A10

Figure 132 (Postflight). This photograph is of the lower left one-sixth of the tray. It shows numerous space debris impact or penetration discolorations. White dots of various sizes are visible on the cover and many appear to be encircling impact locations. The silvered Teflon film surface appears diffuse rather than specular as it was in preflight photographs. One large discoloration spot is in the upper center of the photograph.

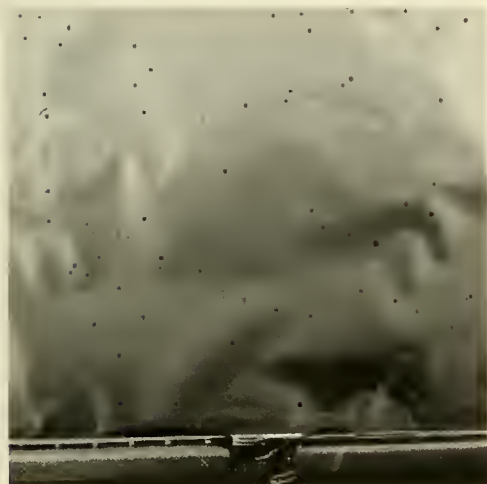
Figure 133
Photo No.: KSC-390C-2208.10
Dup. Neg. No.: L91-7783
LISAR No.: EL-1994-00532
Photo Credit: KSC
Photo Date: 3/22/90
Location: KSC SAEF II
Subject: Postflight Detail of Lower Center of
Tray A10

Figure 133 (Postflight). This photograph is of the lower center one-sixth of the tray. It shows numerous space debris impact or penetration discolorations. White dots of various sizes are visible on the cover and many appear to be encircling impact locations. The silvered Teflon film surface appears diffuse rather than specular as it was in preflight photographs.

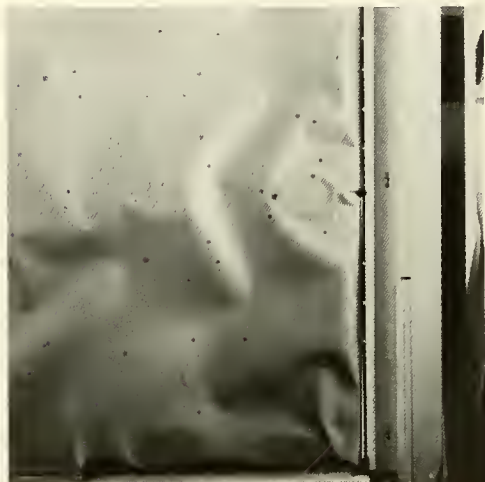
Figure 134 (Postflight). This photograph is of the lower right one-sixth of the tray. It shows numerous space debris impact or penetration discolorations. White dots of various sizes are visible on the cover and many appear to be encircling impact locations. The silvered Teflon film surface appears diffuse rather than specular as it was in preflight photographs.

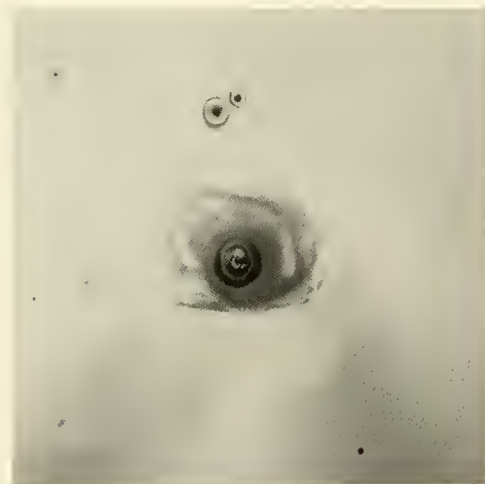
Figure 135 (Postflight). This close-up photograph is of the large discolored impact or penetration located in the lower left one-sixth of the tray. A large lighter area of discoloration surrounds the darker area. The upper left side of the photograph is light because of photographic lights.

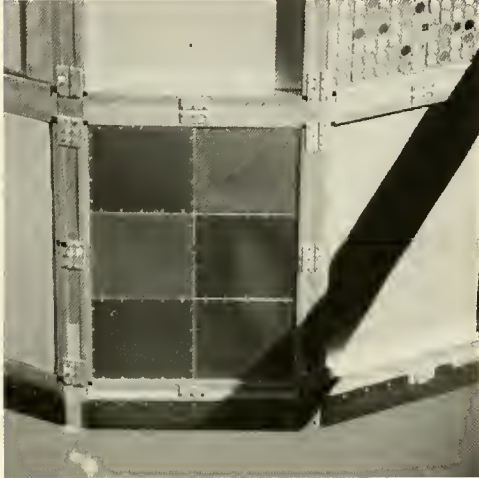
Figure 137 (In Flight). The experiment appears to be intact. Impact craters, which appear as small white imperfections in the dark blue background, are visible on all six detector plates. The apparent dark blue of the aluminum detector panels in this photograph is the result of the lighting and the camera angle.

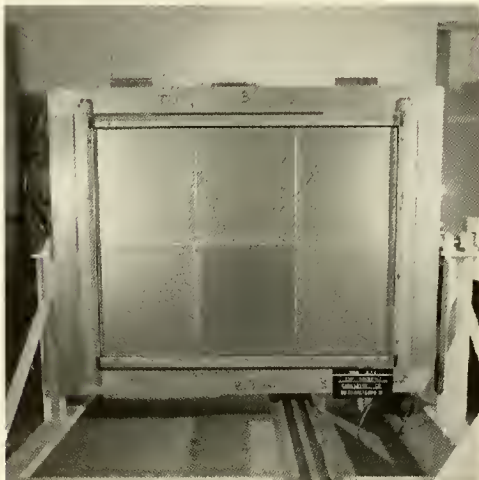
Figure 138 (Postflight). Close inspection of the postflight photograph reveals tiny white spots on the detector plates where impacts have occurred during flight. The largest impact appears to have been on the plate in the lower left corner of the experiment tray.

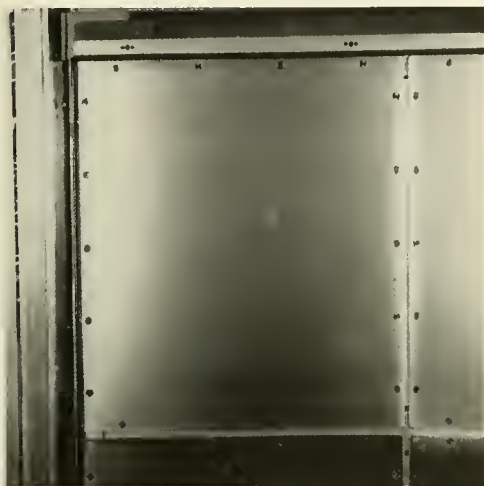
Figure 139
Photo No.: KSC-390C-1697.11
Dup. Neg. No.: L91-7806
LISAR No.: EL-1994-00228
Photo Credit: KSC
Photo Date: 3/7/90
Location: KSC SAEF II
Subject: Postflight Detail of Upper Left Plate of
Tray A11

Figure 139 (Postflight). This close-up photograph is of the upper left plate. The very small white dots are impact craters. The lighter area to the left is a result of photographic light reflections.

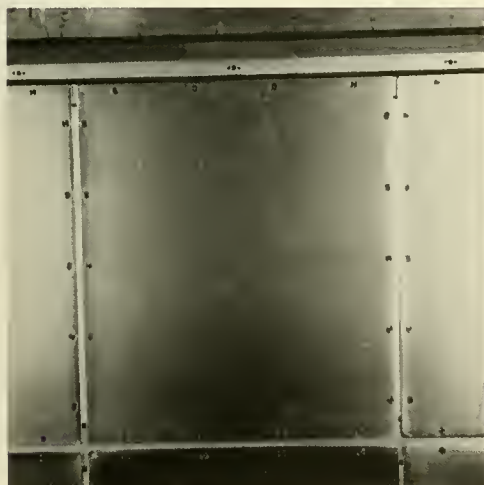
Figure 140
Photo No.: KSC-390C-1697.12
Dup. Neg. No.: L91-7807
LISAR No.: EL-1994-00229
Photo Credit: KSC
Photo Date: 3/7/90
Location: KSC SAEF II
Subject: Postflight Detail of Upper Center Plate of
Tray A11

Figure 140 (Postflight). This close-up photograph is of the upper center plate. The very small white dots are impact craters.

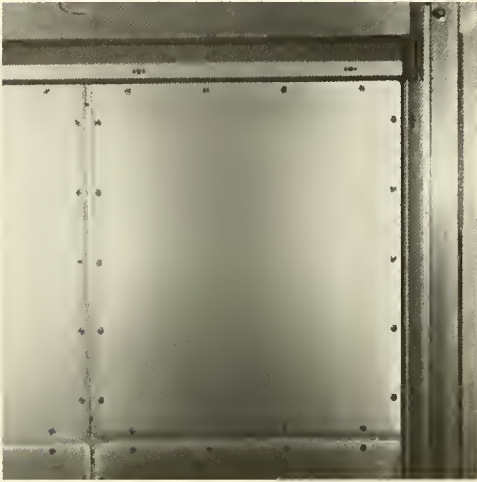
Figure 141 (Postflight). This close-up photograph is of the upper right plate. The very small white dots are impact craters.

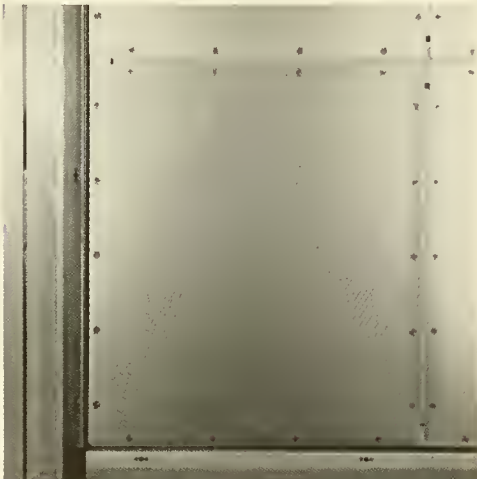
Figure 142 (Postflight). This close-up photograph is of the lower left plate. The very small white dots are impact craters. The upper left has what appears to be a bulge in the panel. This bulge can be found in preflight photographs and is not a result of flight.

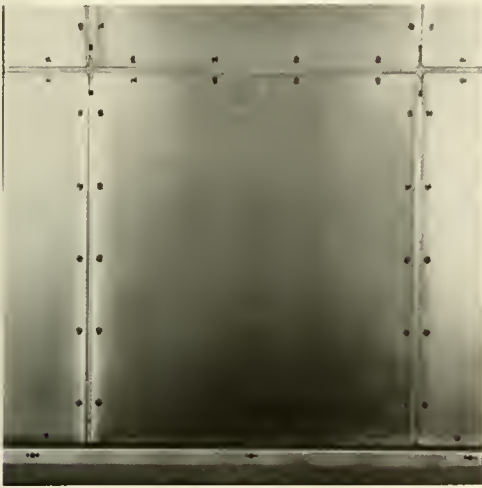
Figure 143
Photo No.: KSC-390C-1699.04
Dup. Neg. No.: L91-7817
LISAR No.: EL-1994-00232
Photo Credit: KSC
Photo Date: 3/7/90
Location: KSC SAEF II
Subject: Postflight Detail of Lower Center Plate of
Tray A11

Figure 143 (Postflight). This close-up photograph is of the lower center plate. The very small white dots are impact craters.

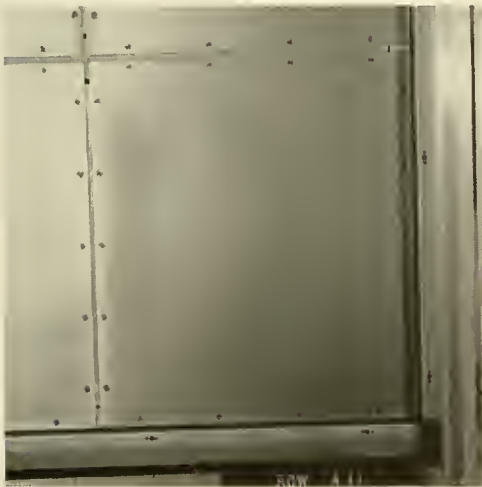
Figure 144
Photo No.: KSC-390C-1699.05
Dup. Neg. No.: L91-7818
LISAR No.: EL-1994-00233
Photo Credit: KSC
Photo Date: 3/7/90
Location: KSC SAEF II
Subject: Postflight Detail of Lower Right Plate of
Tray A11

Figure 144 (Postflight). This close-up photograph is of the lower right plate. The very small white dots are impact craters. The left part of the photograph shows photographic light reflections.

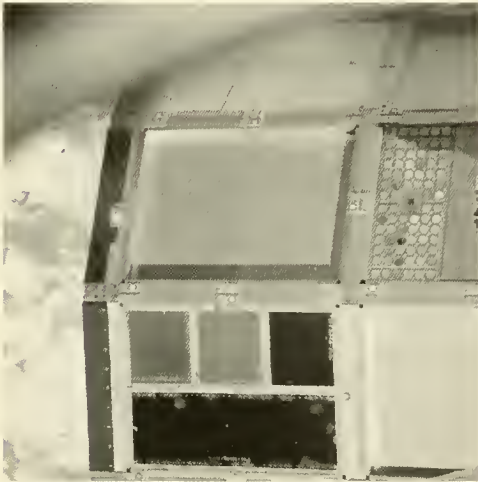
Figure 145 (In Flight). The greenish-gray tint on the two debris panels is the by-product of the chromic anodization coating process. The blue tint can be attributed to reflections of the sky. The vertical streaks on the debris panels are by-products of chromic anodizing; these streaks have been enhanced by the blue reflection. Brown stains are located along the left edge of the right debris panel. An irregular discoloration extends horizontally across the lower half of the left debris panel. The light band along the vertical edge of the left debris panel and across the top of both debris panels is a reflection from the tray sidewall.

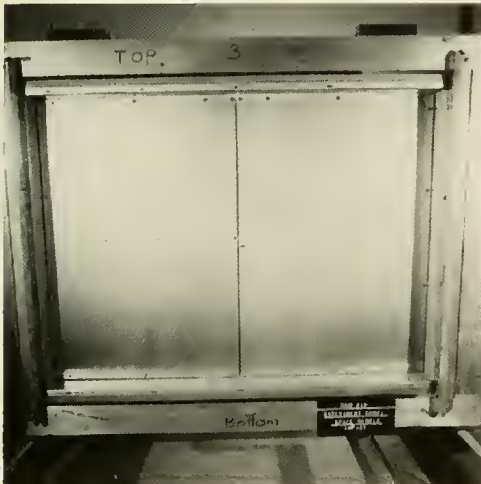
Figure 146
Photo No.: KSC-390C-2163.03
Dup. Neg.: L91-7828
LISAR No.: EL-1994-00472
Photo Credit: KSC
Photo Date: 3/21/90
Location: KSC SAEF II
Subject: Postflight Survey of Tray A12

Figure 146 (Postflight). The pink and greenish-gray tints on the two debris panels are by-products of the chromic anodization coating process and are not attributed to contamination or exposure to the space environment. The vertical streaks observed on the right debris panel in the in-flight photograph are still visible, although they are not as distinct. The irregular discoloration extending horizontally across the left debris panel remains well defined. The light band across the top and bottom of the debris panels is caused by light reflecting from the tray sidewalls.

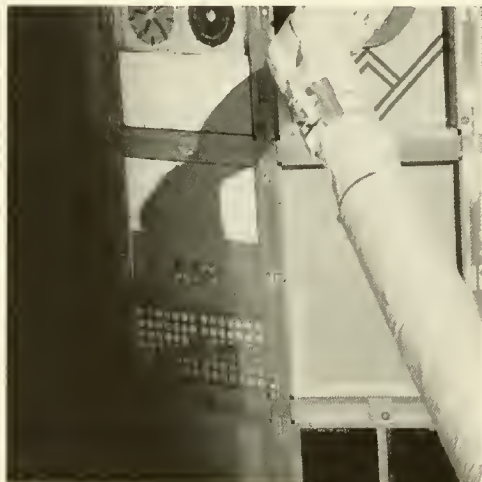
Figure 147 (In Flight). The pink and greenish-gray tints on the two debris panels are by-products of the chromic anodization coating process and are not attributed to contamination or exposure to the space environment.

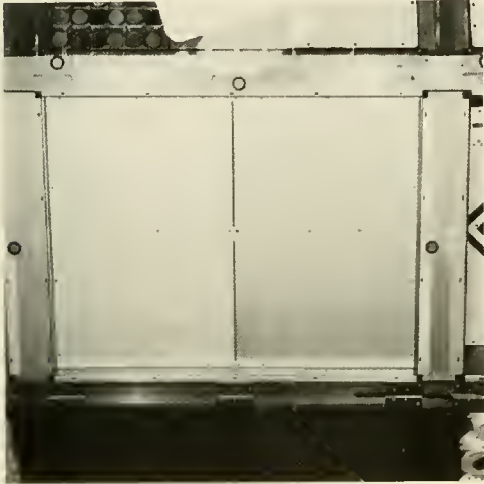
Figure 148
Photo No.: KSC-390C-1066.11
Dup. Neg. No.: L90-13480
LISAR No.: EL-1994-00189
Photo Credit: KSC
Photo Date: 2/8/90
Location: KSC SAEF II
Subject: Postflight Survey of Tray B1

Figure 148 (Postflight). The pink and greenish-gray tints on the two debris panels are by-products of the chromic anodization coating process and are not attributed to contamination or exposure to the space environment. The light bands along the bottom and the left and right edges of the panels are caused by lights reflecting from the tray sidewalls. The two small mounds on the panel on the left are manufacturing defects that existed prior to flight. Markings along the top of the photograph are the result of film processing.

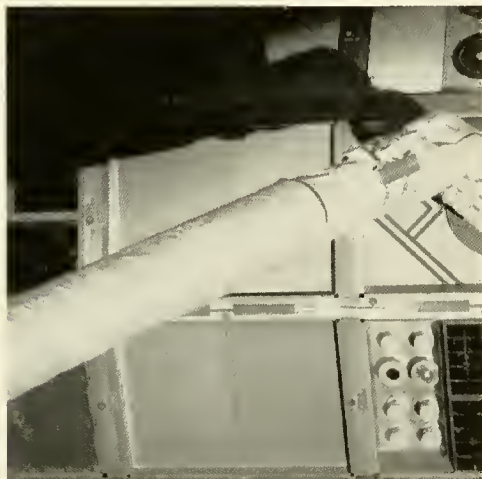
Figure 149 (In Flight). The greenish-gray tint on the left debris panels and the pink tint on the right debris panel are by-products of the chromic anodization coating process. The light band along the left side and across the bottom of the panels is caused by light reflecting from the tray sidewalls.

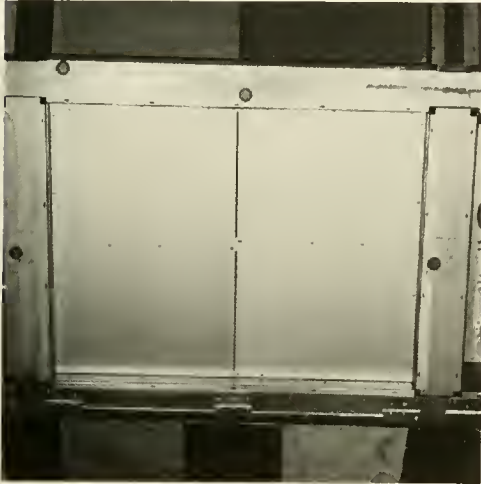
Figure 150 (Postflight). The pink and greenish-gray tints on the two debris panels are by-products of the chromic anodization coating process and are not attributed to contamination or exposure to the space environment. The light band along the sides and across the bottom of the panels is caused by light reflecting from the tray sidewalls.

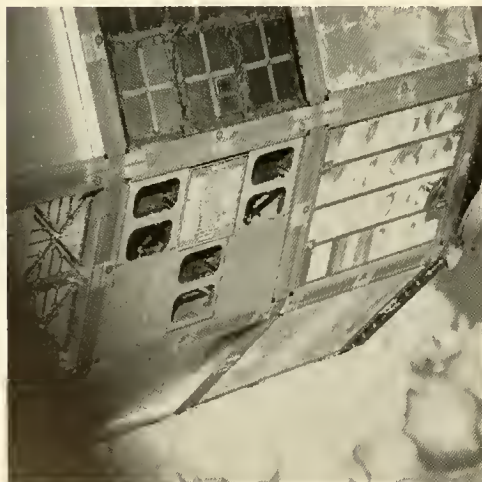
Figure 152 (In Flight). The experiment appears to be without physical damage except for a tear in the material behind the Teflon and glass thermal cover in the lower left corner. Both the mounting plate of the experiment AO138-1 and the plates that provide masks for the open canisters seals have stained surfaces. The exposed experiment mounting plate, however, appears to have a much darker discoloration. The material samples on the top corners of the two upper plates that provide masks for the open canister seals do not appear to be discolored.

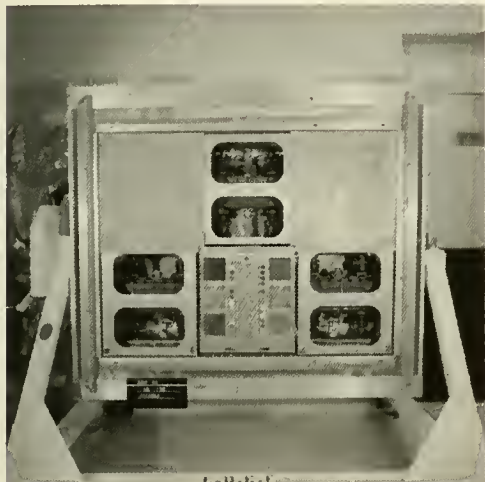
Figure 153
Photo No.: KSC-390C-1646.09
Dup. Neg. No.: L91-7874
LISAR No.: EL-1994-00217
Photo Credit: KSC
Photo Date: 3/6/90
Location: KSC SAEF II
Subject: Postflight Survey of Tray B3

Figure 153 (Postflight). The experiment appears to have no physical damage except for a tear in thermal cover and some discolored areas. The material samples on the bottom corners of the two lower canister cover plates do not appear to be discolored.

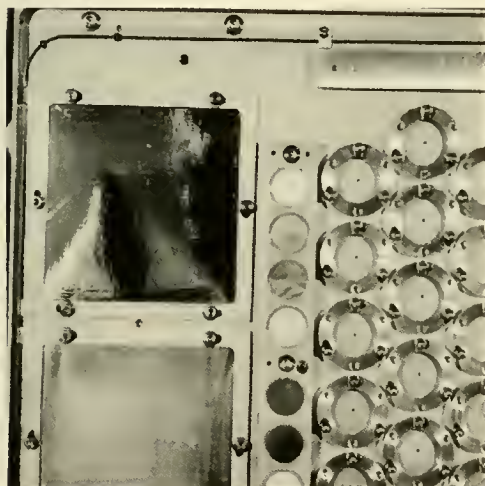
Figure 154
Photo No.: KSC-390C-1648.08
Dup. Neg. No.: L91-7895
LISAR No.: EL-1994-00368
Photo Credit: KSC
Photo Date: 3/6/90
Location: KSC SAEF II
Subject: Postflight Detail of Upper Left of Lower
Center of Tray B3

Figure 154 (Postflight). This close-up of the upper left of the lower center of the tray shows that the experiment mounting plate has a darker color than before flight. The test samples appear wrinkled but are intact.

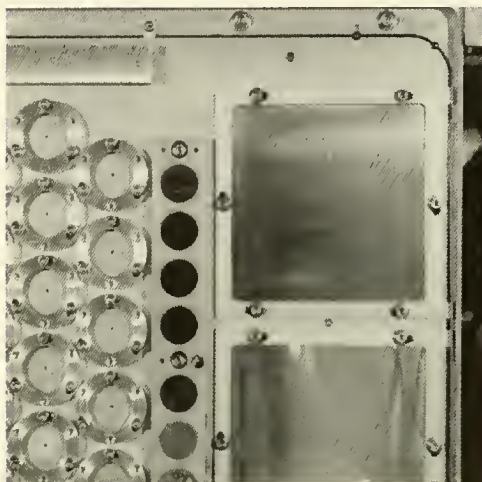
Figure 155 (Postflight). This close-up of the upper right of the lower center of the tray shows that the experiment mounting plate has a darker color than before flight.

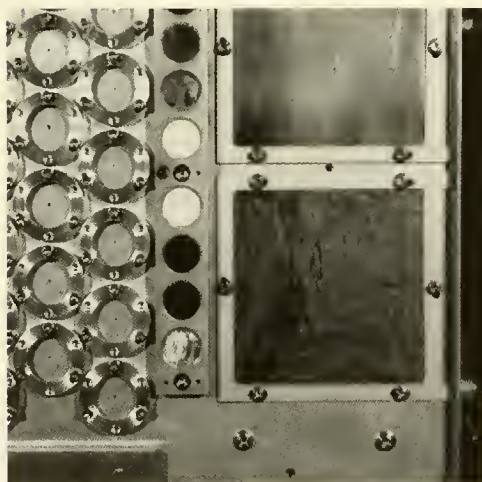
Figure 156 (Postflight). This close-up of the lower right of the lower center of the tray shows that the experiment mounting plate has a darker color than before flight. The test samples appear intact.

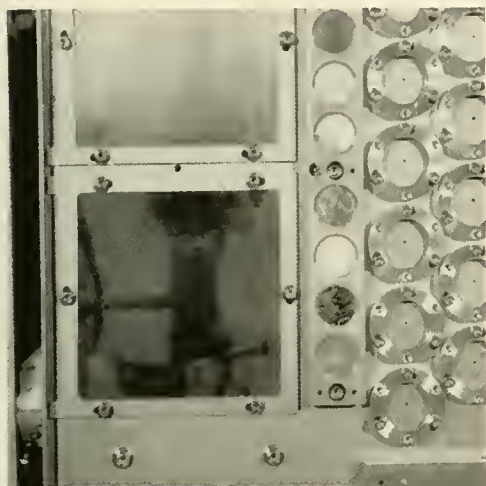
Figure 157 (Postflight). This close-up of the lower left of the lower center tray shows that the experiment mounting plate is a darker color than before flight. The test samples appear wrinkled but are intact.

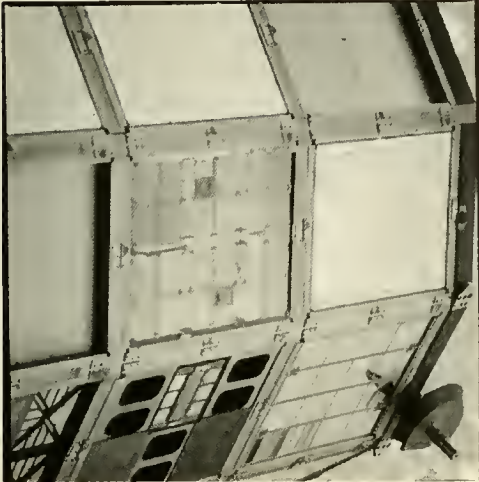
Figure 159
Photo No.: S32-77-027
Dup. Neg.: L90-10407
LISAR No.: EL-1994-00090
Photo Credit: JSC
Photo Date: 1/12/90
Location: In Flight
Subject: In-Flight Survey of Tray B4

Figure 159 (In Flight). The experiment appears to have no physical damage from exposure to the space environment. The lighting is such that changes in material colors are difficult to detect; however, the white paint in the vicinity of the solar cell modules appears to have darkened.

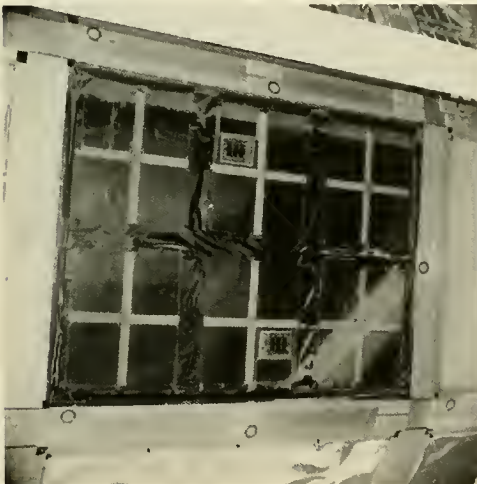
Figure 160
Photo No.: KSC-390C-730.08
Dup. Neg. No.: L92-17647
LISAR No.: EL-1994-00164
Photo Credit: KSC
Photo Date: 2/1/90
Location: KSC O & C building
Subject: Postflight Survey of Tray B4

Figure 160 (Postflight). The experiment appears to be without physical damage. The white paint around the outer edges of the solar cell modules seems to have changed to a light tan.

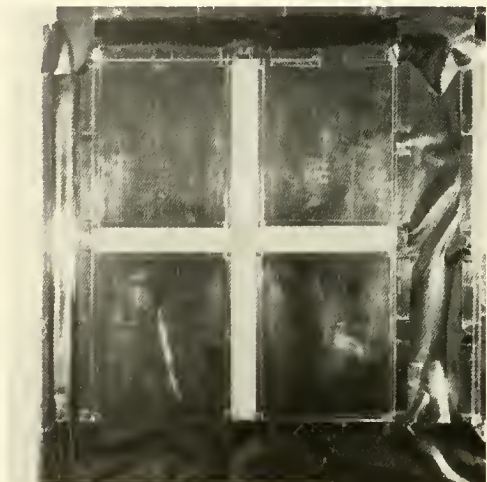
Figure 161 (Postflight). This photograph of the upper left one-sixth of the tray shows that the experiment has no apparent physical damage. Surfaces remain highly reflective.

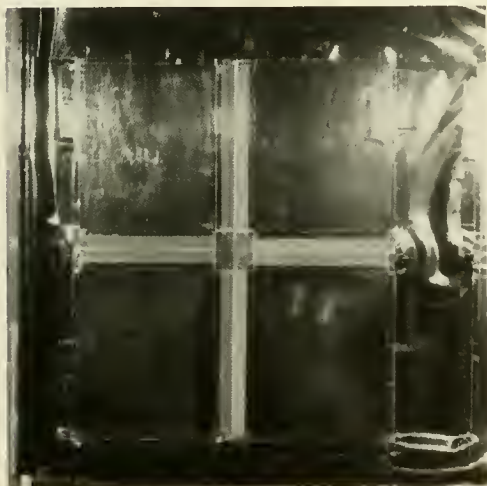
Figure 164 (Postflight). This photograph is of the lower left one-sixth of the tray. It shows the experiment with no apparent physical damage. Surfaces remain highly reflective.

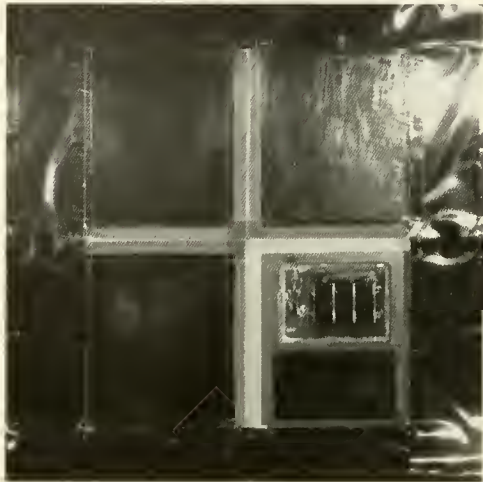
Figure 165 (Postflight). This photograph is of the lower center one-sixth of the tray. It shows the experiment with no apparent physical damage. Surfaces remain highly reflective. The white paint around the outer edges of the solar cell modules has changed to a light tan.

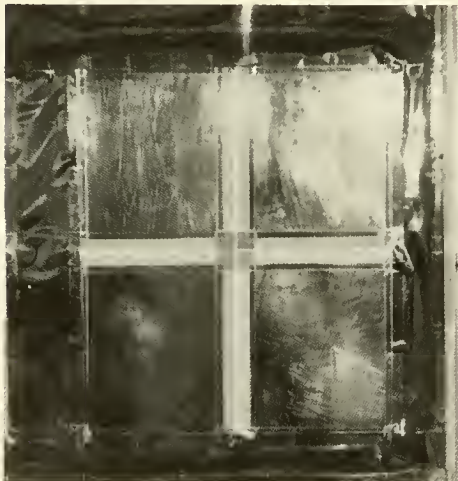
Figure 166 (Postflight). This photograph is of the lower right one-sixth of the tray. It shows the experiment without apparent physical damage. Surfaces remain highly reflective.

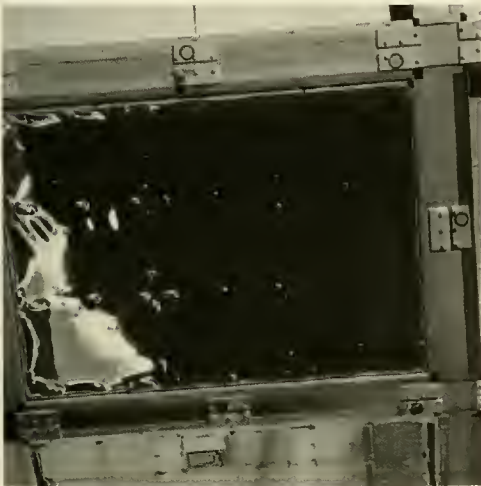
Figure 167 (In Flight). The thermal cover has no apparent damage; however, it is more taut than in the prelaunch photograph. The glossy black appearance of the thermal cover is due to lighting conditions and not to a change in the material optical properties. The bright spots on the dark thermal cover background are areas where Velcro pads are bonded to the back of the cover. The large bright area on the left of the cover is reflected light. The scalloped edge across the top, bottom, and left side of the cover occurs between attachment pads. The ground strap is in place with no visible damage.

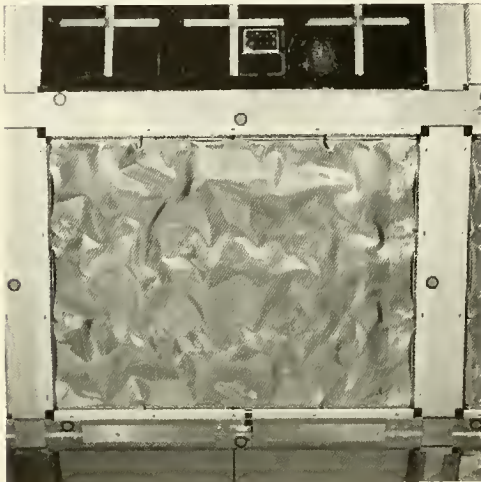
Figure 168
Photo No.: KSC-390C-1035.08
Dup. Neg. No.: L90-13453
LISAR No.: EL-1994-00184
Photo Credit: KSC
Photo Date: 2/9/90
Location: KSC SAEF II
Subject: Postflight Survey of Tray B5

Figure 168 (Postflight). The thermal cover appears to be specular with no apparent damage. The cover is less taut than in the in-flight photograph and the locations of Velcro attachment pads are not as prominent. The scallop effect around the cover edges occurs between the attachment pads and shows the upper edge of the support frame. The ground strap is in place with no visible damage.

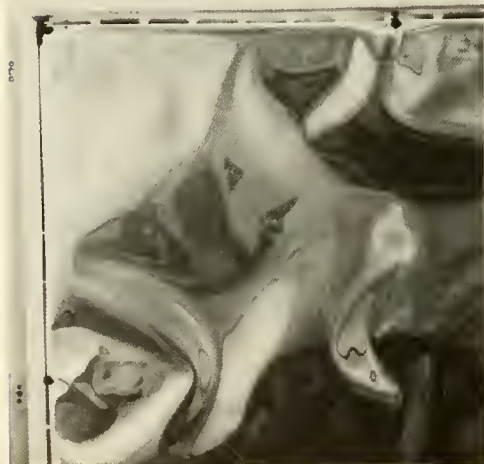
Figure 169
Photo No.: KSC-390C-2151.05
Dup. Neg. No.: L91-7974
LISAR No.: EL-1994-00513
Photo Credit: KSC
Photo Date: 3/21/90
Location: KSC SAEF II
Subject: Postflight Detail of Upper Left of Thermal Cover of Tray B5

Figure 169 (Postflight). This photograph is of the upper left one-sixth of the tray. The thermal cover appears specular with no apparent damage. The reflective properties of the uneven surface of the cover result in various light and color patterns. A few impact or penetration discolorations are visible.

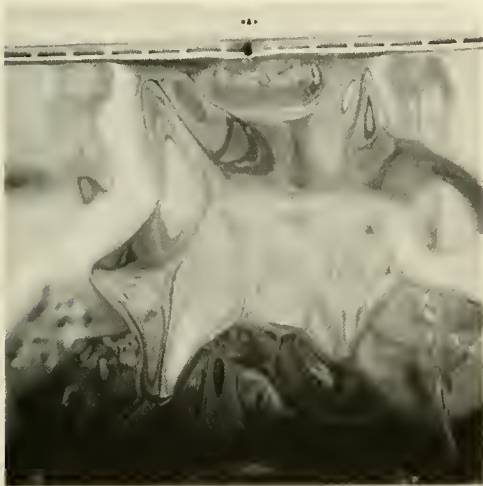
Figure 170
Photo No: KSC-390C-2151.06
Dup. Neg. No.: L91-7975
LISAR No.: EL-1994-00514
Photo Credit: KSC
Photo Date: 3/21/90
Location: KSC SAEF II
Subject: Postflight Detail of Upper Center of
Thermal Cover of Tray B5

Figure 170 (Postflight). This photograph is of the upper center one-sixth of the tray. The thermal cover appears specular with no apparent damage. The reflective properties of the uneven surface of the cover result in various light and color patterns. A few impact or penetration discolorations are visible.

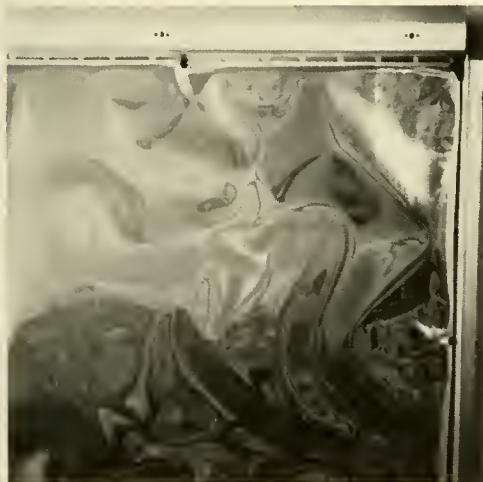
Figure 171
Photo No.: KSC-390C-2151.07
Dup. Neg. No.: L91-7976
LISAR No.: EL-1994-00515
Photo Credit: KSC
Photo Date: 3/21/90
Location: KSC SAEF II
Subject: Postflight Detail of Upper Right of Thermal
Cover of Tray B5

Figure 171 (Postflight). This photograph is of the upper right one-sixth of the tray. The pattern enhanced by reflected light in the upper right corner of the thermal cover existed during preflight and was not due to space exposure. The thermal cover appears specular with no apparent damage. The reflective properties of the uneven surface of the cover result in various light and color patterns. A few impact or penetration discolorations are visible.

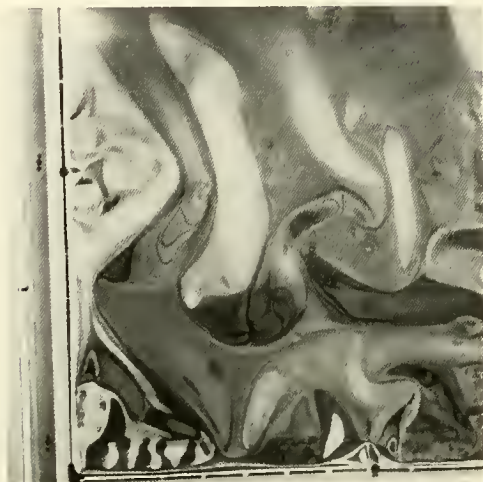
Figure 172 (Postflight). This photograph is of the lower left one-sixth of the tray. The thermal cover appears specular with no apparent damage. The reflective properties of the uneven surface of the cover result in various light and color patterns. A few impact or penetration discolorations are visible.

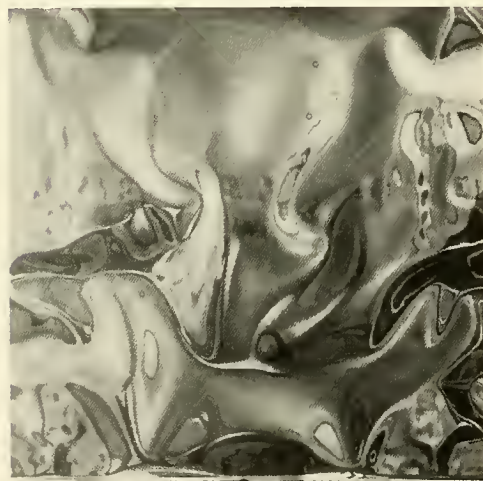
Figure 173 (Postflight). This photograph is of the lower center one-sixth of the tray. The thermal cover appears specular with no apparent damage. The reflective properties of the uneven surface of the cover result in various light and color patterns. A few impact or penetration discolorations are visible.

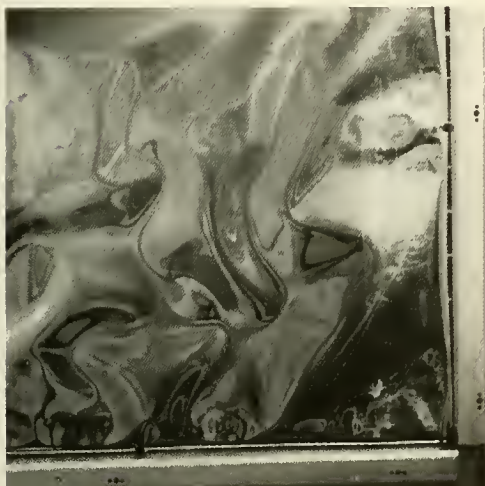
Figure 174 (Postflight). This photograph is of the lower right one-sixth of the tray. The pattern enhanced by reflected light along the right edge of the thermal cover existed preflight and was not due to space exposure. The thermal cover appears specular with no apparent damage. The reflective properties of the uneven surface of the cover result in various light and color patterns. A few impact or penetration discolorations are visible.

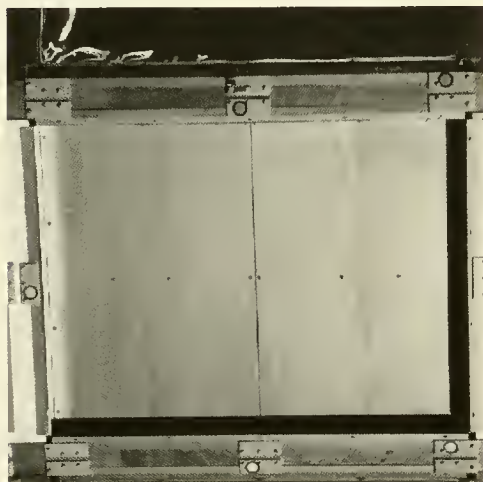
Figure 175 (In Flight). A portion of the greenish-gray tint on the two debris panels is the product of the chromic anodization coating process; however, a large part can be attributed to reflections of the blue sky. The vertical streaks on the panels are products of chromic anodizing that have been enhanced significantly by the blue reflection. Fingerprints along the center edges of the debris panels occurred during experiment assembly and indicate improper pre-flight handling or cleaning.

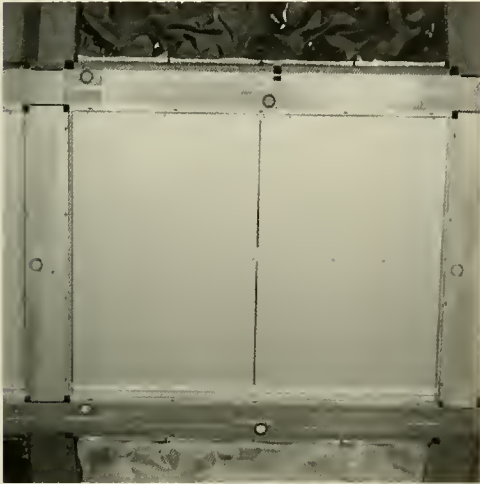
Figure 176
Photo No.: KSC-390C-1146.03
Dup. Neg. No.: L90-13505
LISAR No.: EL-1994-00192
Photo Credit: KSC
Photo Date: 2/18/90
Location: SAEF II at KSC
Subject: Postflight Survey of Tray B6

Figure 176 (Postflight). The pink and greenish-gray tints on the two debris panels are by-products of the chromic anodization coating process and are not attributed to contamination or exposure to the space environment. The fingerprints along the inner edges of the debris panels that were observed in the in-flight photograph are still visible. The dark vertical streaks on the debris panels in the in-flight photographs are almost invisible because the reflection of the sky is not present. The light band along the sides and across the bottom of the panels is caused by light reflecting from the tray sidewalls.

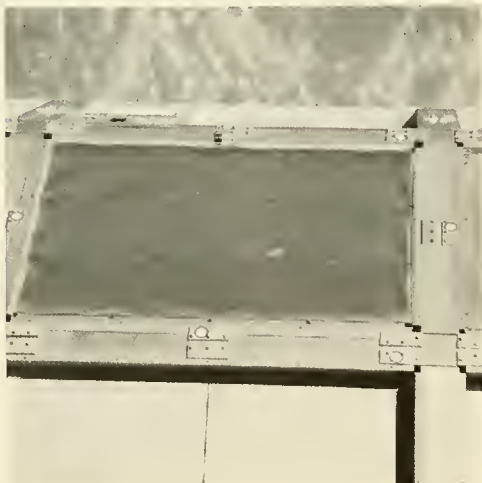
Figure 177 (In Flight). The thermal cover appears to have no apparent damage, but it is more taut than in the prelaunch photograph. The dark blue appearance of the thermal cover in this photograph is caused by lighting conditions and is not due to a change in the optical properties of the material. The oblong indentations on the thermal cover are areas where Velcro pads are bonded to the back of the cover. The surface of the thermal cover appears to have small brown circular discolorations of various sizes that appear to result from impacts or penetrations. A large light blue area of discoloration is clearly visible in the lower right quadrant of the thermal cover. The discoloration is probably the result of an impact penetrating the 5-mil Teflon film and upsetting the layer of vapor-deposited silver beneath. The scalloped edge along the left side of the thermal cover occurs between attachment pads. The ground strap appears to be in place with no visible damage, but it appears to be a deeper copper color than in the pre-launch photograph.

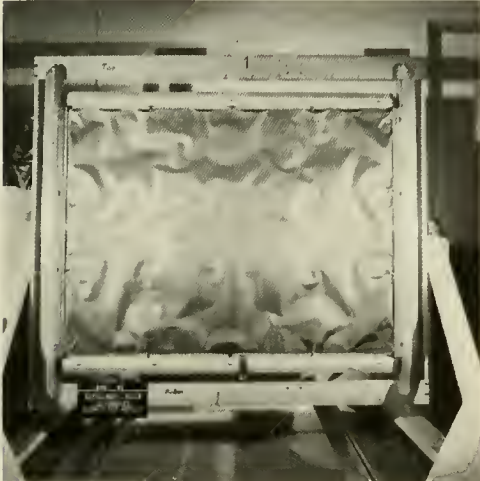
Figure 178
Photo No.: KSC-390C-2306.09
Dup. Neg. No.: L91-8035
LISAR No.: EL-1994-00312
Photo Credit: KSC
Photo Date: 3/26/90
Location: KSC SAEF II
Subject: Postflight Survey of Tray B7

Figure 178 (Postflight). The surface of the thermal cover appears to have changed from specular to opaque with black dots of various sizes that appear to be impacts or penetrations. A large area of white discoloration is clearly visible in the upper left quadrant of the thermal cover. The discoloration is probably the result of a penetration of the 5-mil Teflon film that has affected the layer of vapor-deposited silver beneath. The cover is not as taut as in the in-flight photograph and the locations of Velcro attachment pads are not as prominent. The ground strap is in place with no visible damage, but it is a deeper copper color than in the prelaunch photograph.

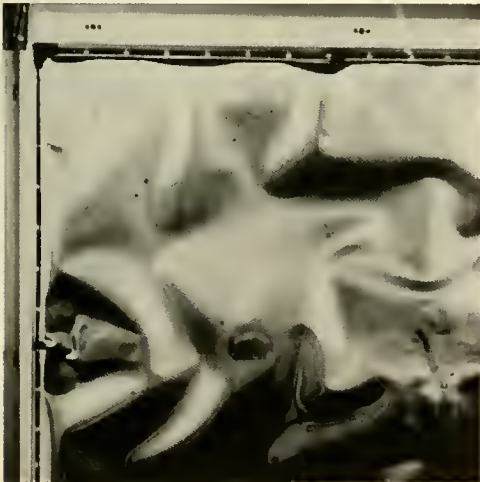
Figure 179
Photo No.: KSC-390C-2306.10
Dup. Neg. No.: L91-8036
LISAR No.: EL-1994-00573
Photo Credit: KSC
Photo Date: 3/26/90
Location: KSC SAEF II
Subject: Postflight Detail of Upper Left of Thermal
Cover of Tray B7

Figure 179 (Postflight). This close-up photograph is of the upper left one-sixth of the tray. The thermal cover appears to be opaque rather than specular as it was in preflight photographs. Numerous impact or penetration discolorations are visible. The thermal cover Velcro tie-down pads are also evident.

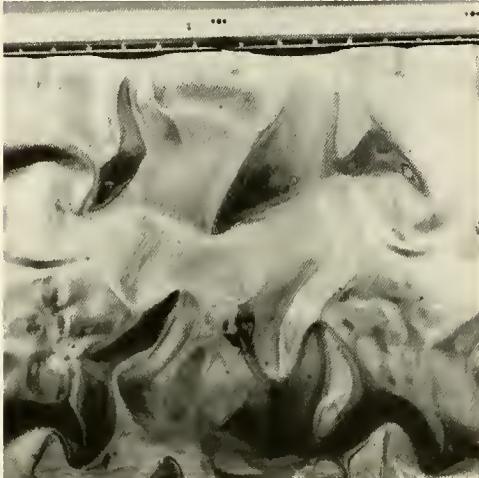
Figure 180 (Postflight). This close-up photograph is of the upper center one-sixth of the tray. The thermal cover appears to be opaque rather than specular as it was in preflight photographs. Numerous impact or penetration discolorations are visible. The thermal cover Velcro tie-down pads are also evident.

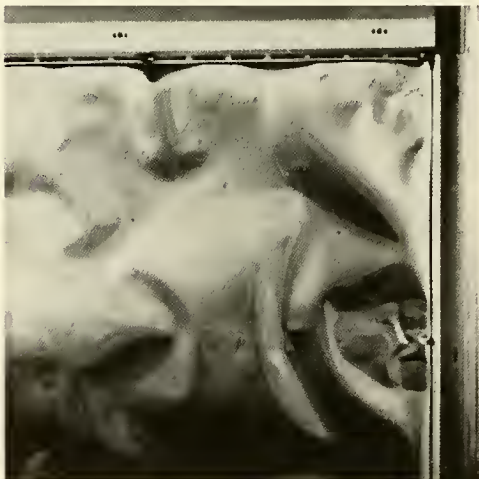
Figure 181 (Postflight). This close-up photograph is of the upper right one-sixth of the tray. The thermal cover appears to be opaque rather than specular as it was in preflight photographs. Numerous impact or penetration discolorations are visible. The thermal cover Velcro tie-down pads are also evident.

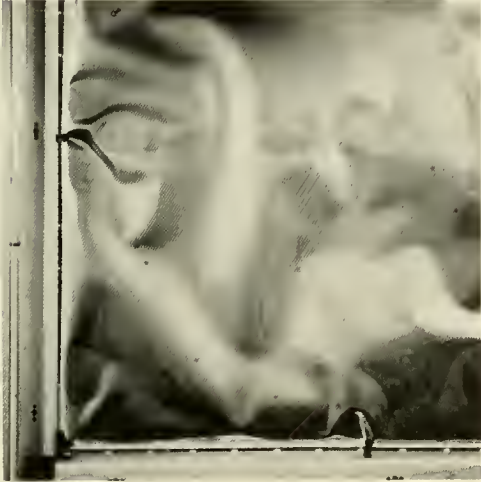
Figure 182 (Postflight). This close-up photograph is of the lower left one-sixth of the tray. The thermal cover appears to be opaque rather than specular as it was in preflight photographs. Numerous impact or penetration discolorations are visible. The thermal cover Velcro tie-down pads are also evident.

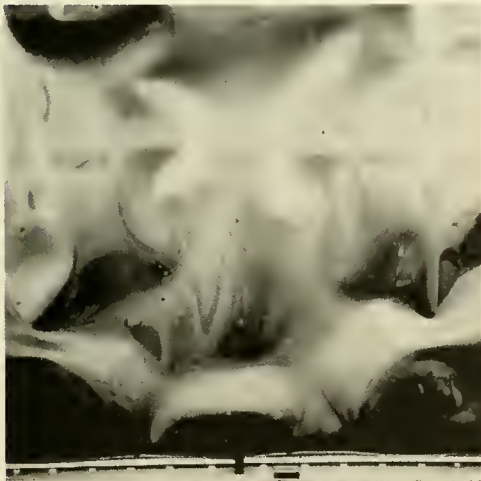
Figure 183 (Postflight). This close-up photograph is of the lower center one-sixth of the tray. The thermal cover appears to be opaque rather than specular as it was in preflight photographs. Numerous impact or penetration discolorations are visible. The thermal cover Velcro tie-down pads are also evident.

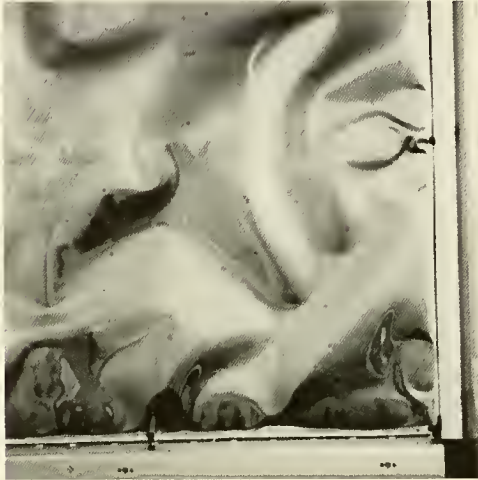
Figure 184 (Postflight). This close-up photograph is of the lower right one-sixth of the tray. The thermal cover appears to be opaque rather than specular as it was in preflight photographs. Numerous impact or penetration discolorations are visible. The thermal cover Velcro tie-down pads are also evident.

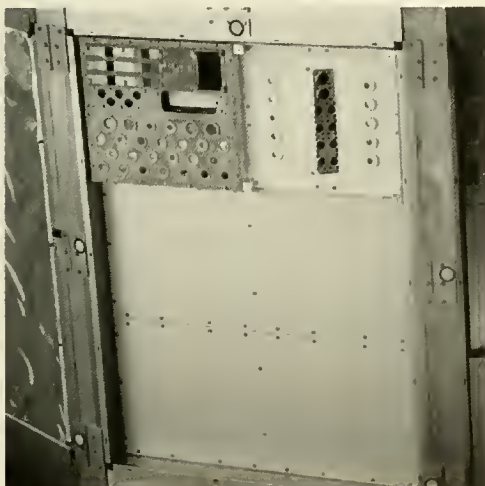
Figure 186
Photo No.: S32-76-026
Dup. Neg. No.: L90-10380
LISAR No.: EL-1994-00665
Photo Credit: JSC
Photo Date: 1/12/90
Location: In Flight
Subject: In-Flight Survey of Tray B8

Figure 186 (In Flight). Here, the space debris impact panels have a very distinct green and pink color that varies as the light angle changes across the panels. The different colors of the infrared filter surfaces of experiment AO056 may be reflections of the surrounding environment and are not from exposure to space. A brown discoloration is present on the surface of the unpainted aluminum mounting plate. Experiment AO147 appears to have no physical damage. The white paint on the aluminum mounting plate has several irregular-shaped black marks along the top edge. The marks were not visible on the prelaunch photograph.

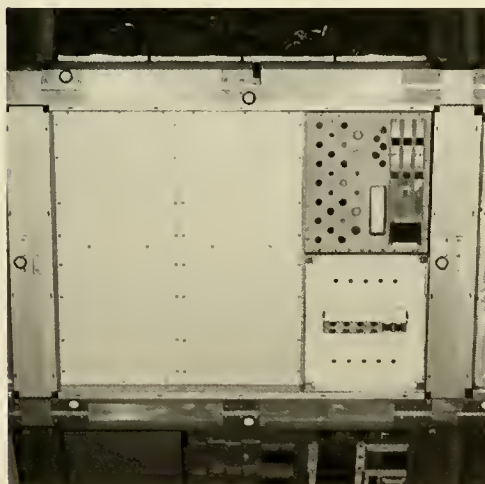
Figure 187
Photo No.: KSC-390C-1031.11
Dup. Neg. No.: L90-13421
LISAR No.: EL-1994-00146
Photo Credit: KSC
Photo Date: 2/9/90
Location: KSC SAEF II
Subject: Postflight Survey of Tray B8

Figure 187 (Postflight). Experiment AO056 appears unchanged from the in-flight photograph. The apparent blue, green, silver, and white colors of coatings and filter samples observed in the in-flight photographs are not visible. A brown discoloration is present on the surface of the unpainted aluminum mounting plate. The discoloration is darker near the fasteners around the mounting plate edges and the filter and coating holders. Experiment AO147, which is located in the lower right of the tray, appears to be without physical damage. Experiment S0001 shows the familiar green and pink that is caused by anodization.
